Confidential Inspection Report

LOCATED AT:
1 Sample Ln
Sample, Maryland

INSPECTED ON:
Sunday, November 18, 2018

Homecheckit Summary

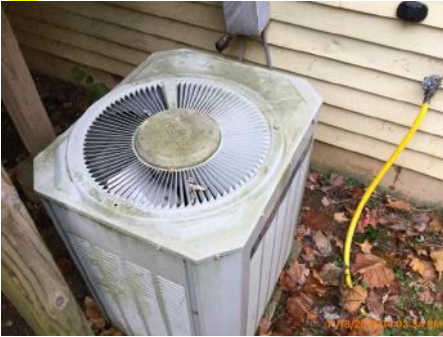
AIR CONDITIONING

AGED s-4: - Estimated to be approximately 27 years old and in working condition

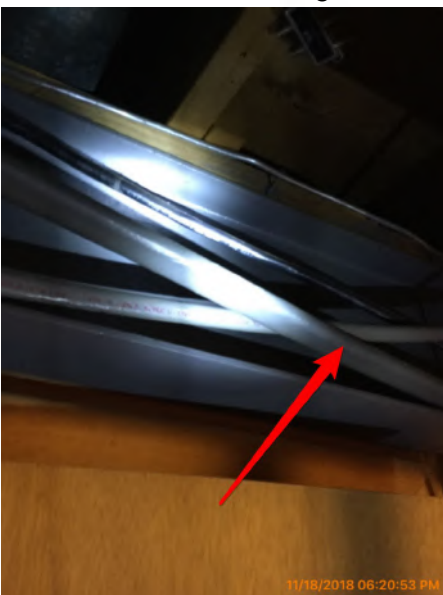
BRANCH CIRCUITRY

ATTN s-18: - Improper wiring methods have been employed in numerous instances throughout the system. We recommend all wiring be attached correctly.

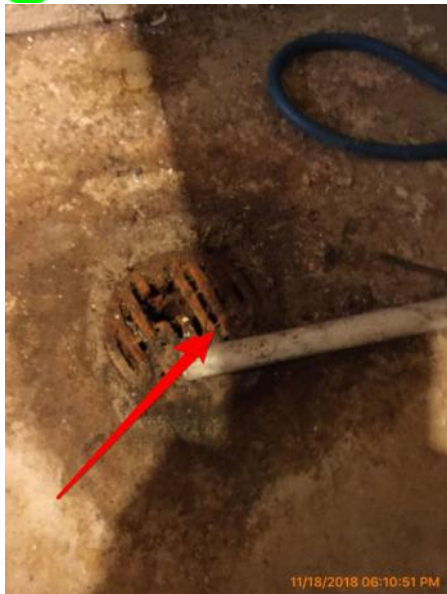
**CLEANOUT
PLUMBING**

MINR s-19: - The cleanout cap at the laundry sink is damaged. We recommend it be replaced.

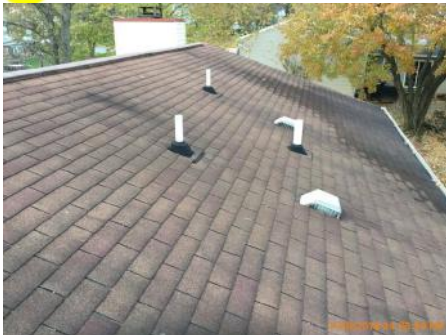
AGED s-24: - Age: Approximately 26 years old, no leaks found in attic.

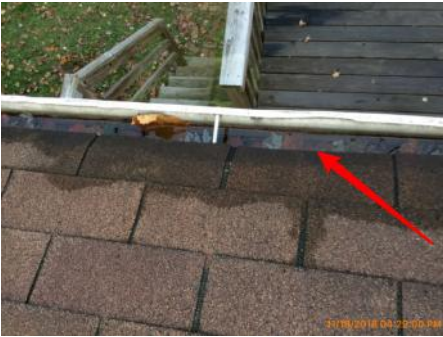
GUTTERS

ATTN s-26: - Debris was present in the gutters, which limited our visual inspection. We recommend all debris be removed to ensure proper drainage. The condition of the gutters can be better assessed at that time.

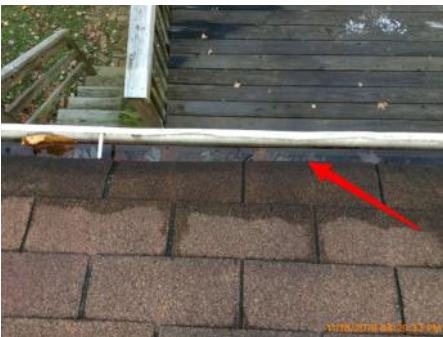
ATTN s-27: - Portions of the gutters were filled with water at the time of this inspection. We recommend all debris be removed and the downspouts be flushed to ensure proper drainage. The condition of the gutters can be better assessed at that time.

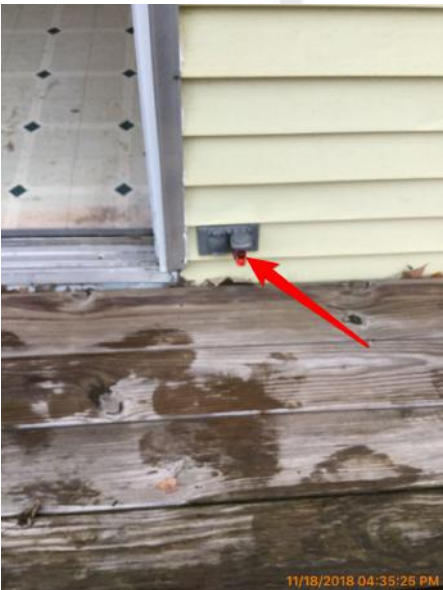
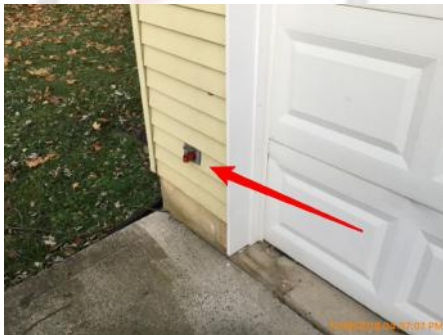
OUTDOOR RECEPTACLES

ATTN s-39: - GFCI protection was not found where this feature is now required. We recommend GFCI protection be installed front and back of house

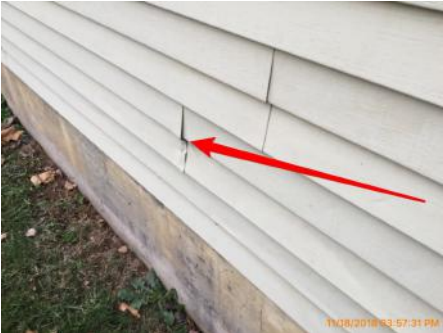
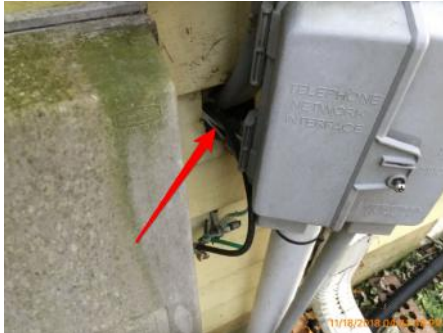
ALUMINUM SIDING
EXTERIOR/SITE/GROUND

MINR s-40: - The aluminum siding appears to be properly installed and generally in good condition, with exceptions noted below.
Right side has a dented area.
Siding needs filling in with plumbers putty where electric sec cable enters house to keep mice out.

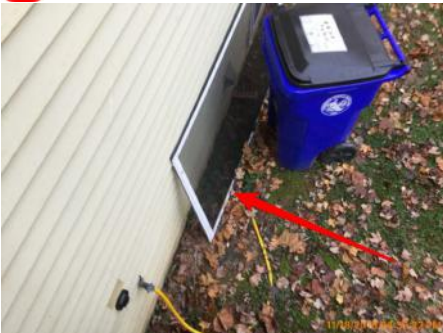
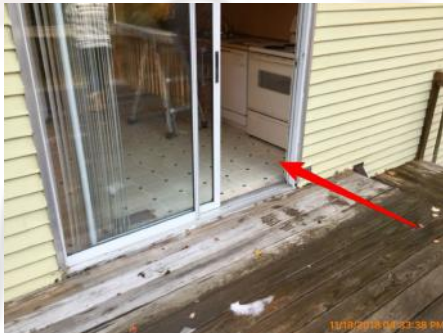
DOORS
EXTERIOR/SITE/GROUND

ATTN s-41: - The deck screen door is damaged. We recommend it be repaired or replaced.

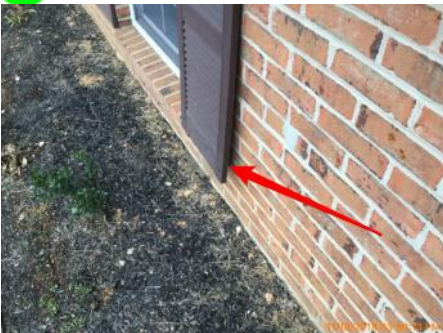
WINDOWS
EXTERIOR/SITE/GROUND

MINR s-42: - Window shutter is loose

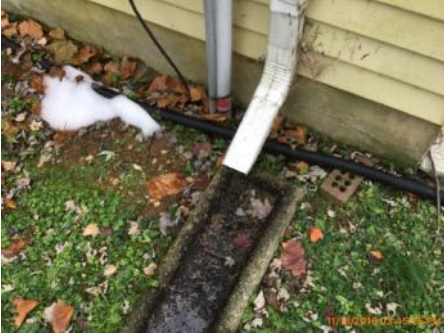
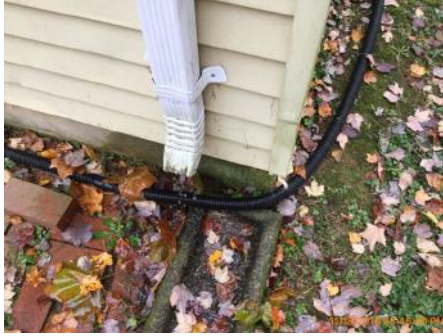
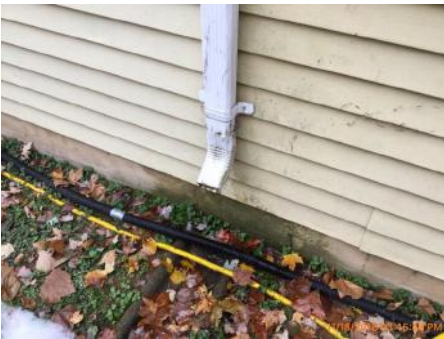
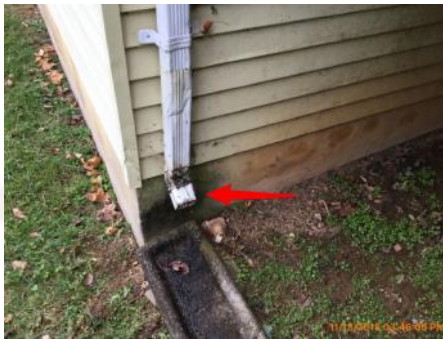
DOWNSPOUTS

ATTN s-43: - Runoff water from the roof discharges next to the house. We recommend the downspouts be routed sufficiently away from the structure to prevent puddling, pooling, and saturation of the soil around the building.

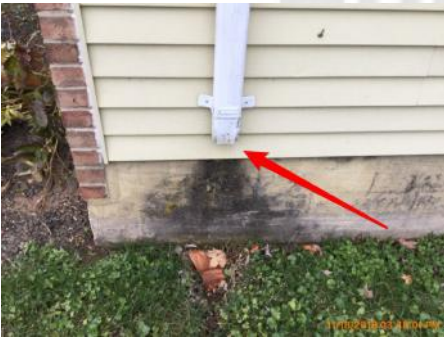
ATTN s-44: - The lower section of the downspout, or elbow is missing at the right side front. We recommend it be replaced to help direct water away from the foundation.

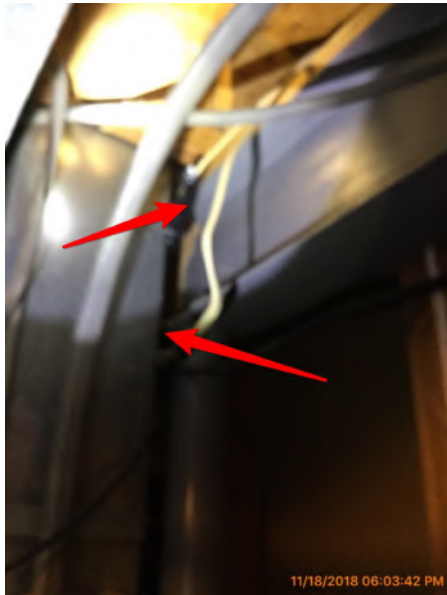
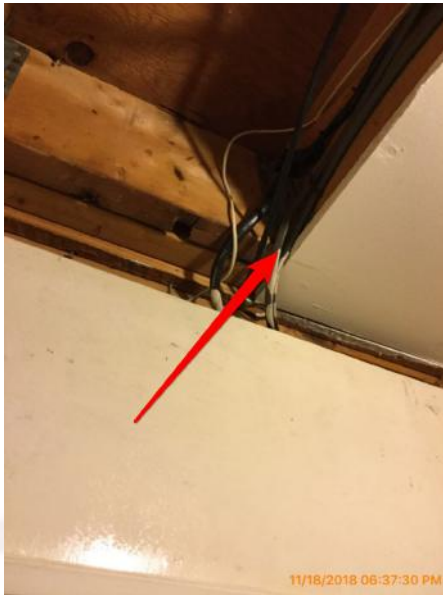
WIRING BASEMENT

ATTN s-46: - Running splices, which are improper connections outside a junction box, were observed. We recommend connections be joined with approved connectors inside a junction box to prevent accidental contact or mechanical damage. Several found in basement

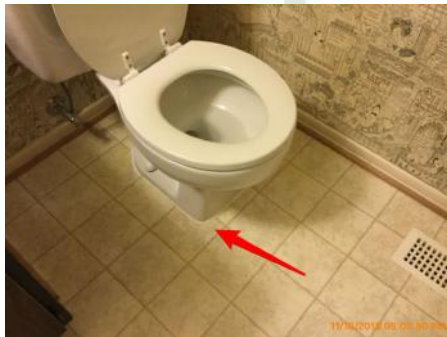
TOILET GUEST HALLWAY BATHROOM

ATTN s-47: - The toilet is loose at the floor. While no damage was evident, this condition should be taken care of so that leakage does not develop and cause damage. We recommend that the toilet be removed and rebolted with a new wax seal.

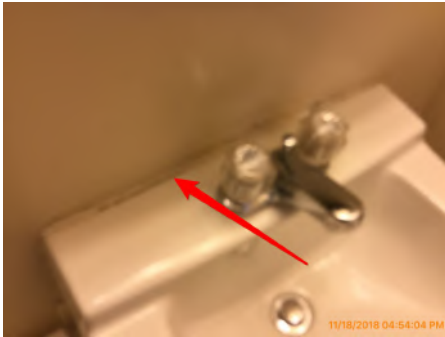
WATER BASIN

ATTN **s-48:** - The wash basin is sagging at its attachment on the wall. We recommend the wash basin be securely fastened.

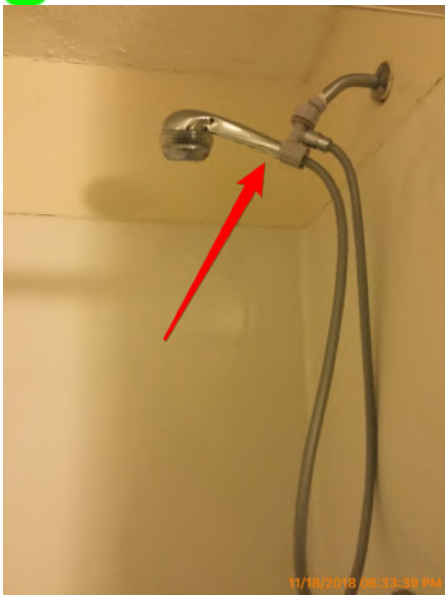
FIXTURES

MINR **s-49:** - The shower head is leaking. We recommend the shower head be repaired or replaced.

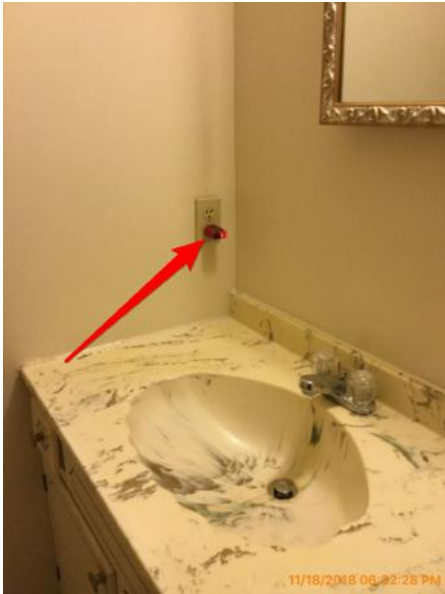
RECEPTACLES

ATTN s-50: - The receptacles in this bathroom are loose. For maximum safety we recommend that they be resecured.

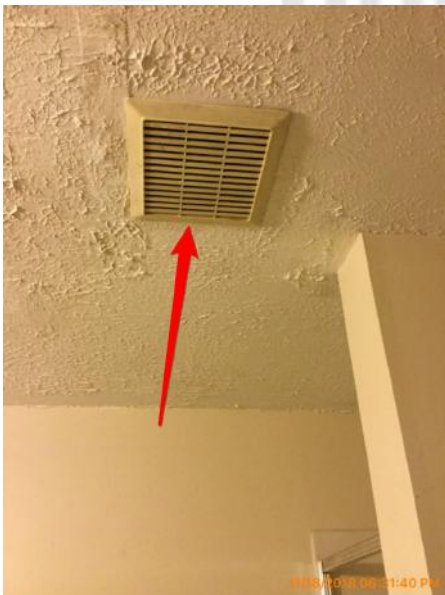
VENTILATION

MINR s-51: - The exhaust fan is very noisy and is not likely to be used in its present condition. We recommend that it be serviced or replaced to restore quite operation.

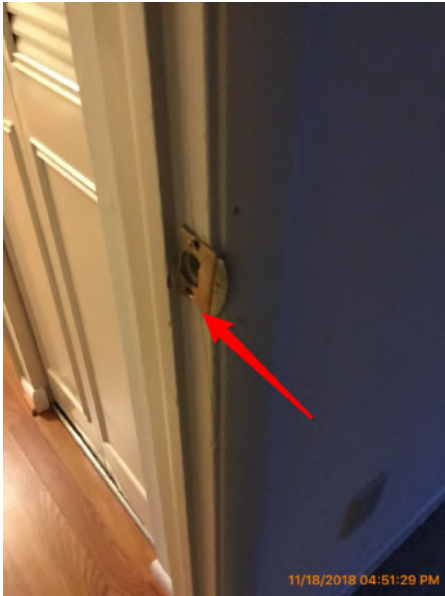
DOORS
BEDROOM

MINR s-52: - The door doesn't latch. We recommend minor adjustments to the hardware to restore proper function.

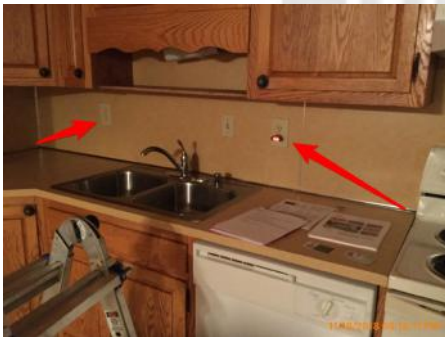
RECEPTACLES
KITCHEN

ATTN s-53: - There is no GFCI (ground fault circuit interrupter) protection for the countertop receptacle(s) within six feet of the sink. For an increased margin of safety, we recommend the installation of a GFCI receptacle(s).

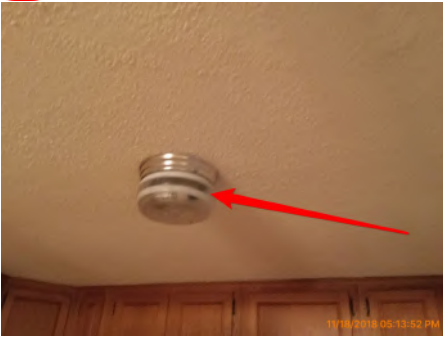
LIGHTS
KITCHEN

ATTN s-54: - The kitchen light fixture is damaged. We recommend it be repaired or replaced.

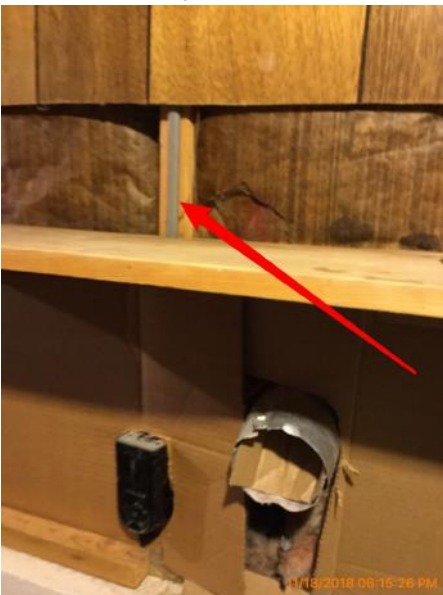
WIRING
LAUNDRY AREA

ATTN s-56: - We found exposed wiring at the dryer vent. Installed on top of 2x4
Install correctly

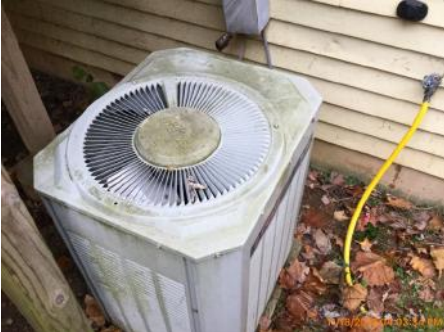
- 1: - Method of cooling: Gas compression
- 2: - Number of units: 1
- 3: - Location of equipment: Single package system
- AGED** 4: - Estimated to be approximately 27 years old and in working condition

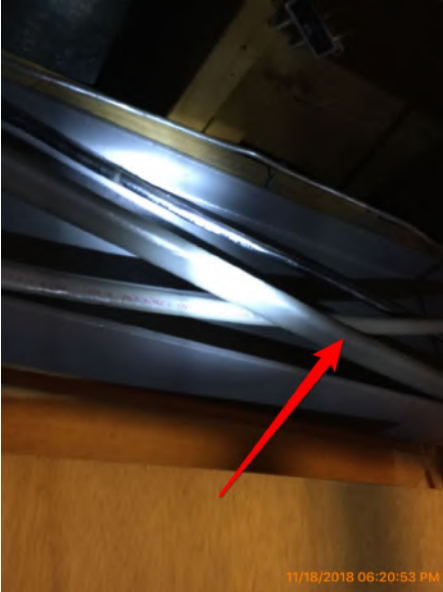
BRANCH CIRCUITRY

ATTN 18: - Improper wiring methods have been employed in numerous instances throughout the system. We recommend all wiring be attached correctly.

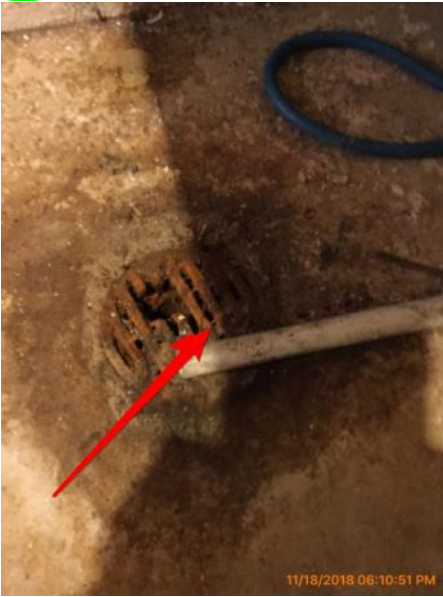
CLEANOUT

MNR 19: - The cleanout cap at the laundry sink is damaged. We recommend it be replaced.

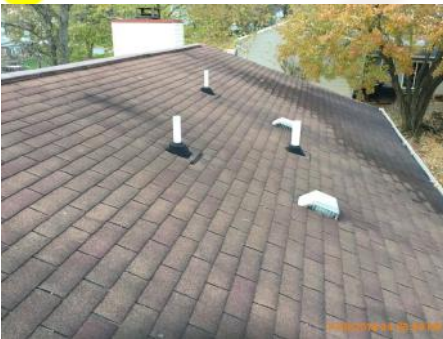
AGED **24:** - Age: Approximately 26 years old, no leaks found in attic.

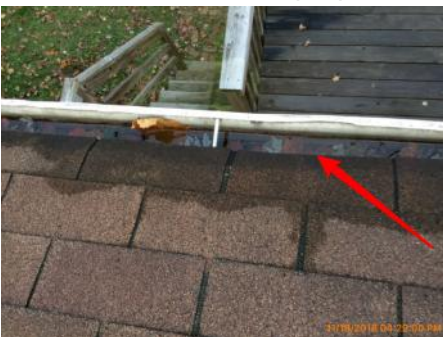
GUTTERS

ATTN **26:** - Debris was present in the gutters, which limited our visual inspection. We recommend all debris be removed to ensure proper drainage. The condition of the gutters can be better assessed at that time.

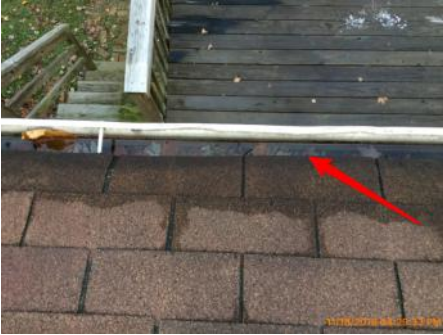
ATTN 27: - Portions of the gutters were filled with water at the time of this inspection. We recommend all debris be removed and the downspouts be flushed to ensure proper drainage. The condition of the gutters can be better assessed at that time.

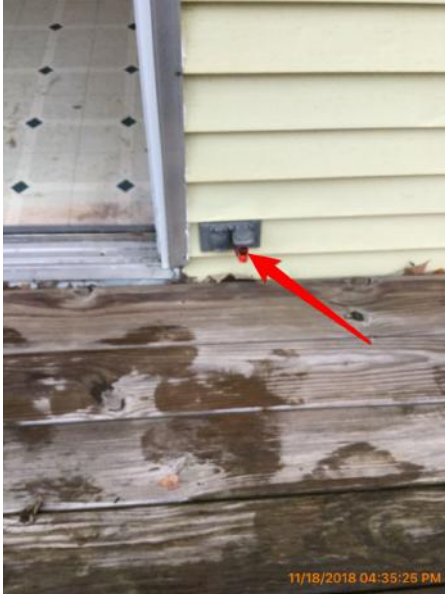
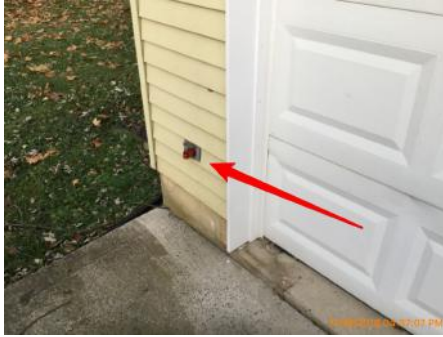
OUTDOOR RECEPTACLES

ATTN 39: - GFCI protection was not found where this feature is now required. We recommend GFCI protection be installed front and back of house

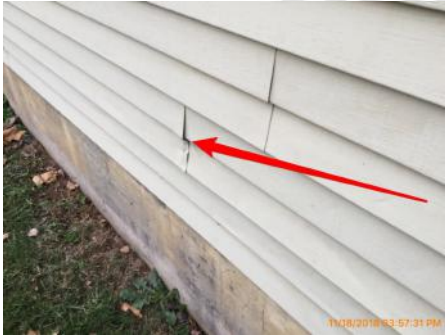
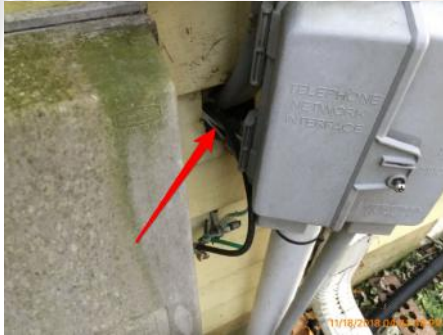
ALUMINUM SIDING

MINR 40: - The aluminum siding appears to be properly installed and generally in good condition, with exceptions noted below. Right side has a dented area. Siding needs filling in with plumbers putty where electric sec cable enters house to keep mice out.

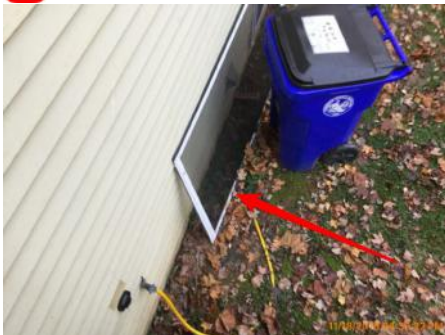
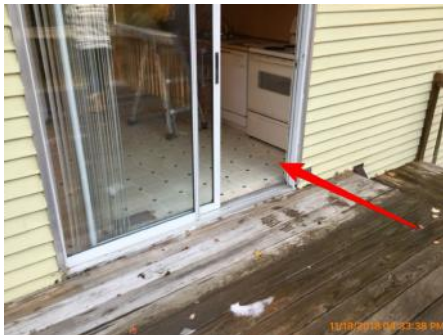
DOORS

ATTN 41: - The deck screen door is damaged. We recommend it be repaired or replaced.

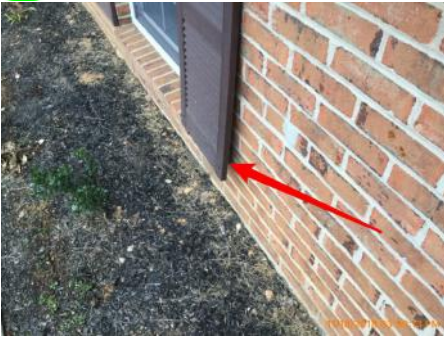
WINDOWS

MINR 42: - Window shutter is loose

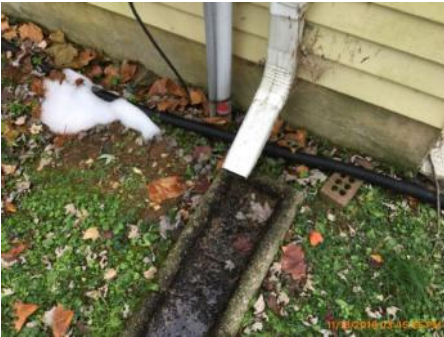
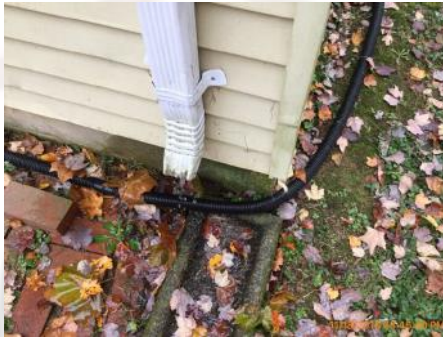
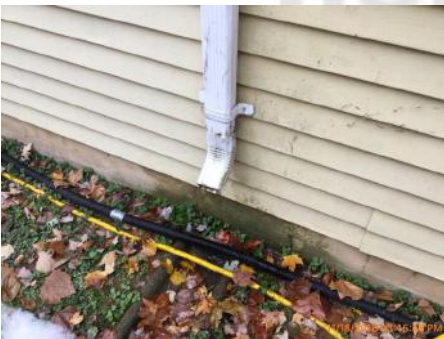
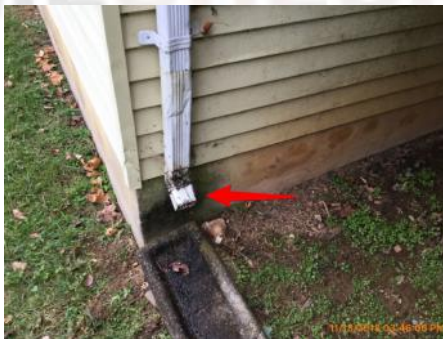
DOWNSPOUTS

ATTN 43: - Runoff water from the roof discharges next to the house. We recommend the downspouts be routed sufficiently away from the structure to prevent puddling, pooling, and saturation of the soil around the building.

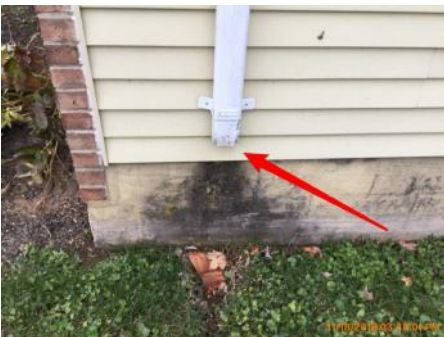
ATTN 44: - The lower section of the downspout, or elbow is missing at the right side front. We recommend it be replaced to help direct water away from the foundation.

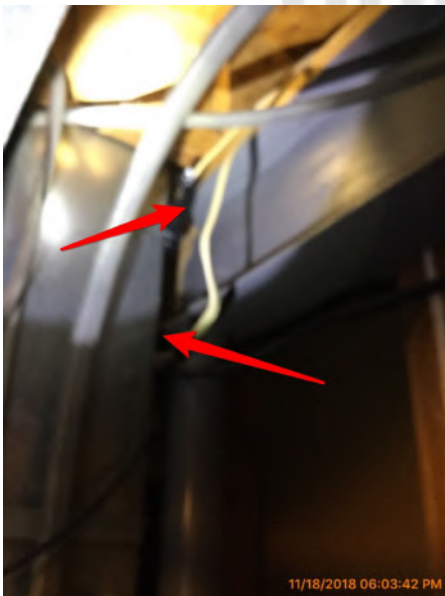
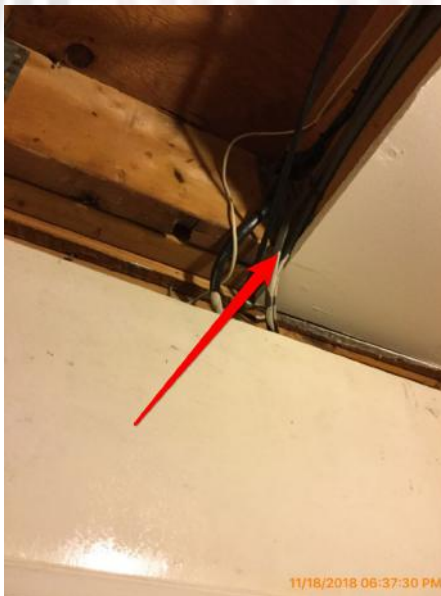
WIRING

ATTN 46: - Running splices, which are improper connections outside a junction box, were observed. We recommend connections be joined with approved connectors inside a junction box to prevent accidental contact or mechanical damage. Several found in basement

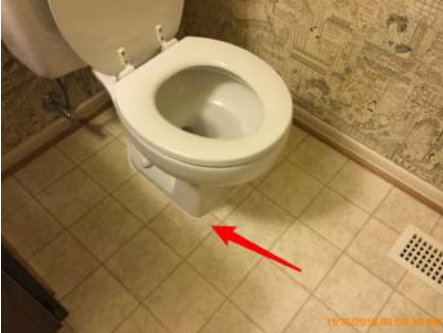
TOILET

ATTN 47: - The toilet is loose at the floor. While no damage was evident, this condition should be taken care of so that leakage does not develop and cause damage. We recommend that the toilet be removed and rebolted with a new wax seal.

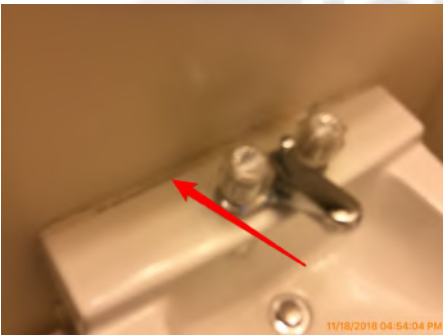
WATER BASIN

ATTN 48: - The wash basin is sagging at its attachment on the wall. We recommend the wash basin be securely fastened.

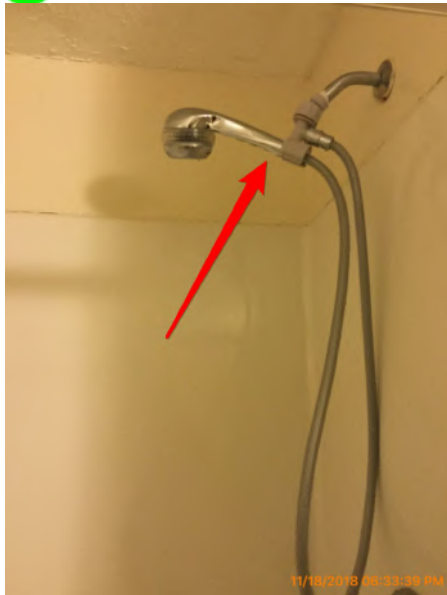
FIXTURES

MINR 49: - The shower head is leaking. We recommend the shower head be repaired or replaced.

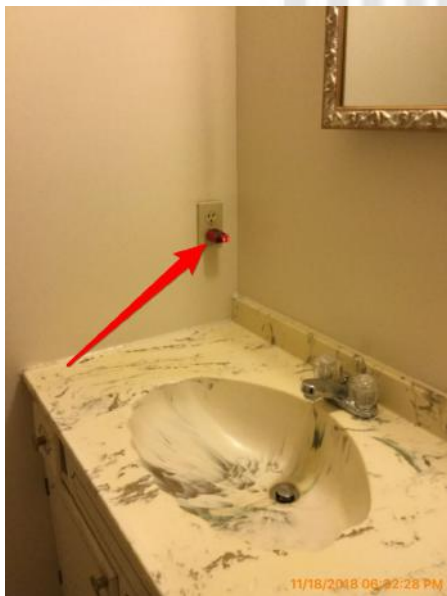
RECEPTACLES

ATTN 50: - The receptacles in this bathroom are loose. For maximum safety we recommend that they be resecured.

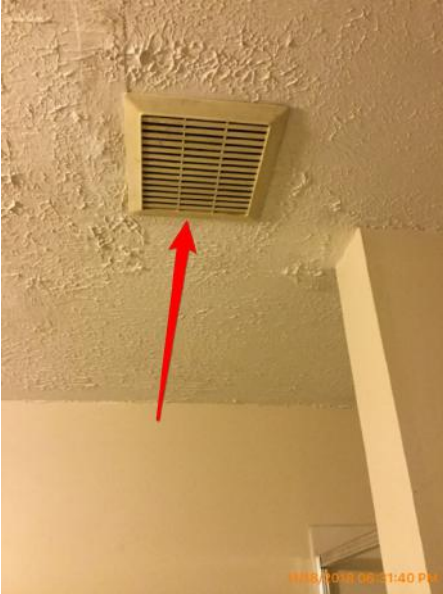
VENTILATION

MINR 51: - The exhaust fan is very noisy and is not likely to be used in its present condition. We recommend that it be serviced or replaced to restore quite operation.

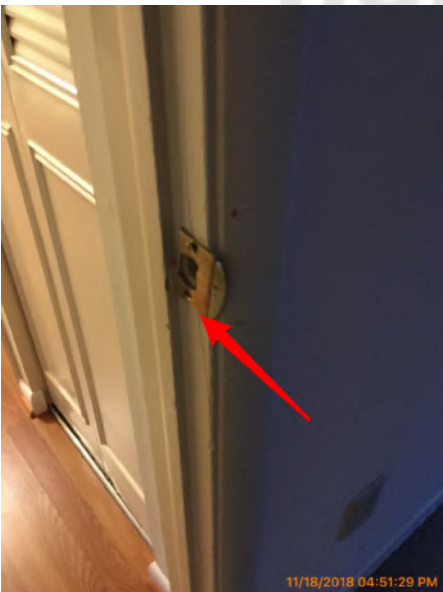
DOORS

MINR 52: - The door doesn't latch. We recommend minor adjustments to the hardware to restore proper function.

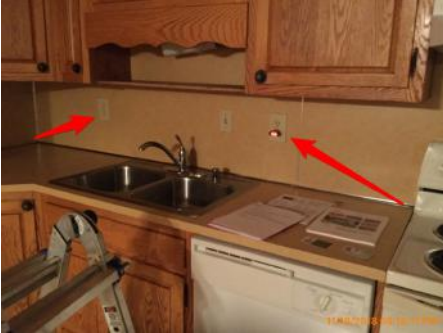
RECEPTACLES

ATTN 53: - There is no GFCI (ground fault circuit interrupter) protection for the countertop receptacle(s) within six feet of the sink. For an increased margin of safety, we recommend the installation of a GFCI receptacle(s).

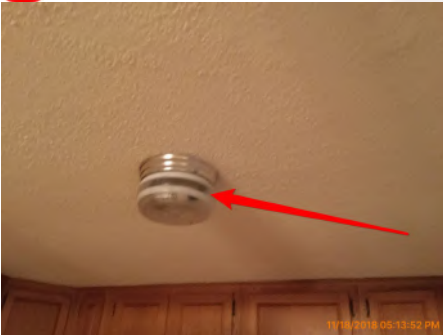
LIGHTS

ATTN 54: - The kitchen light fixture is damaged. We recommend it be repaired or replaced.

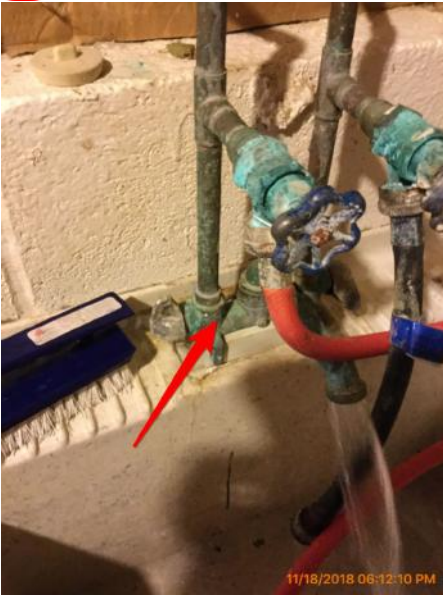
FIXTURES

ATTN 55: - The laundry faucets are leaking. We recommend they be repaired or replaced.

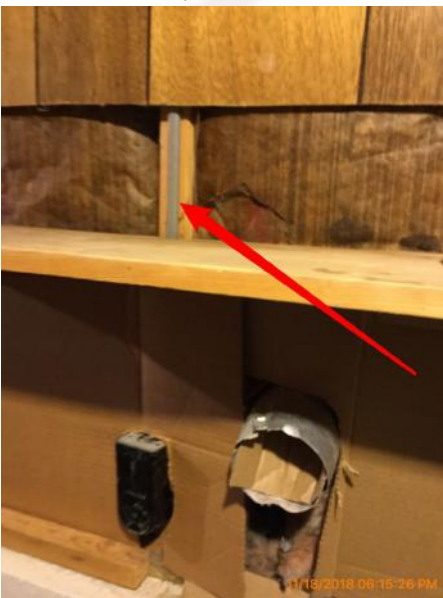
WIRING

ATTN 56: - We found exposed wiring at the dryer vent. Installed on top of 2x4
Install correctly
