Confidential Inspection Report

LOCATED AT:
1 Sample Ln
Sample, Maryland

INSPECTED ON:
Sunday, November 18, 2018

Homecheckit Summary

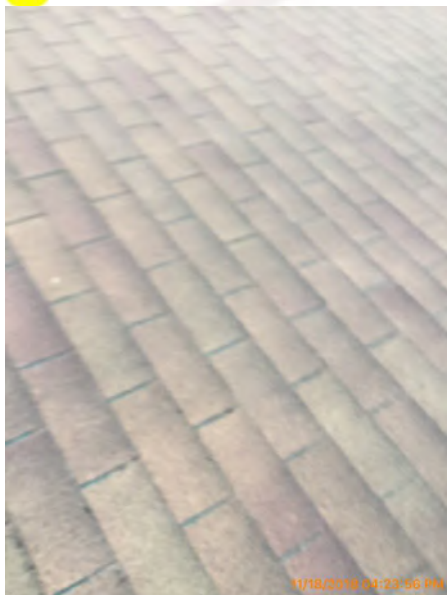
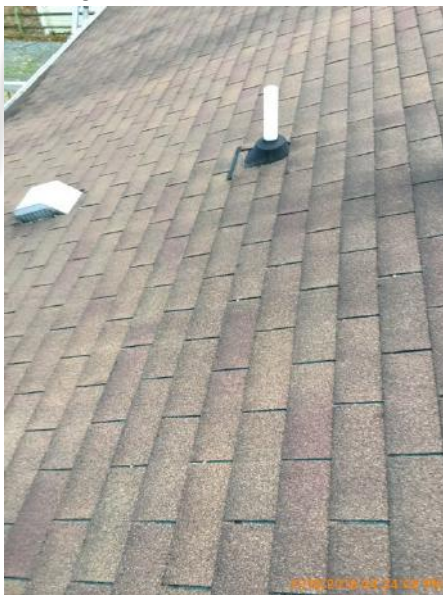
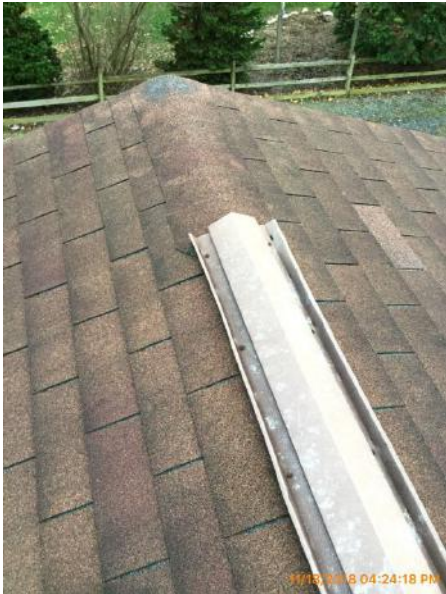
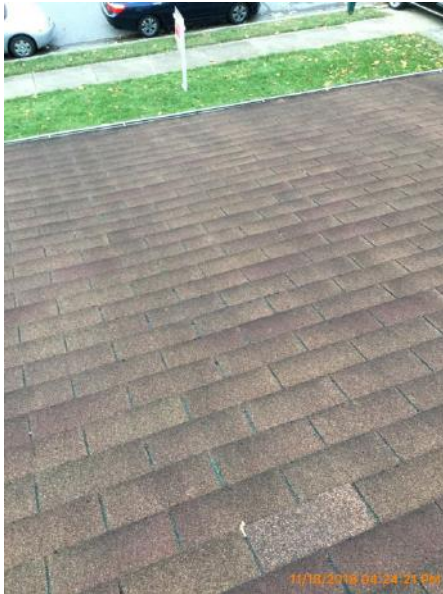
AGED s-20: - Location: Covers whole building

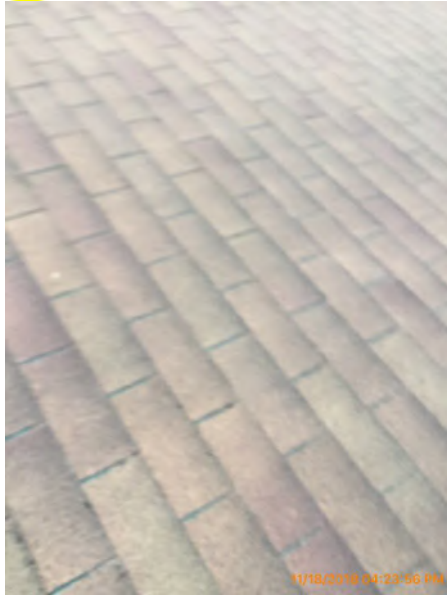
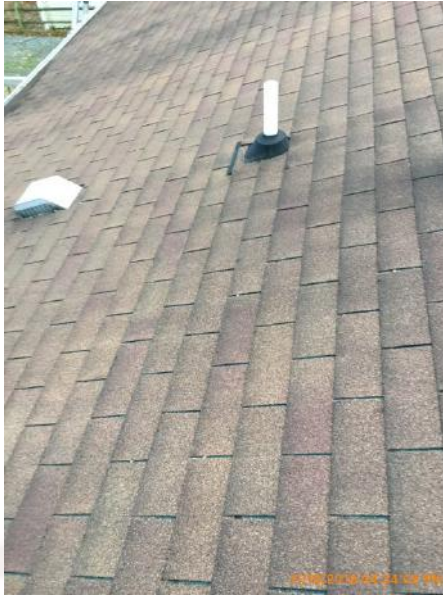
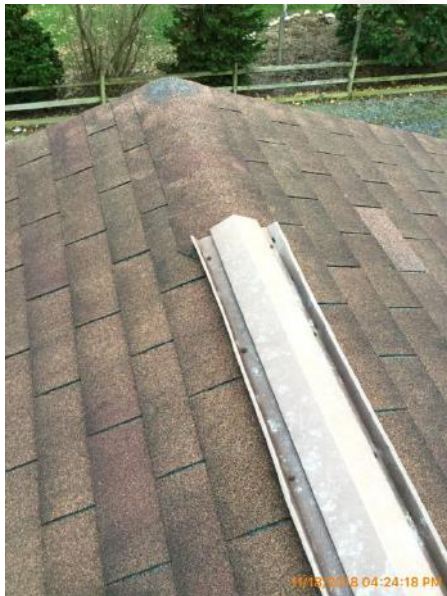
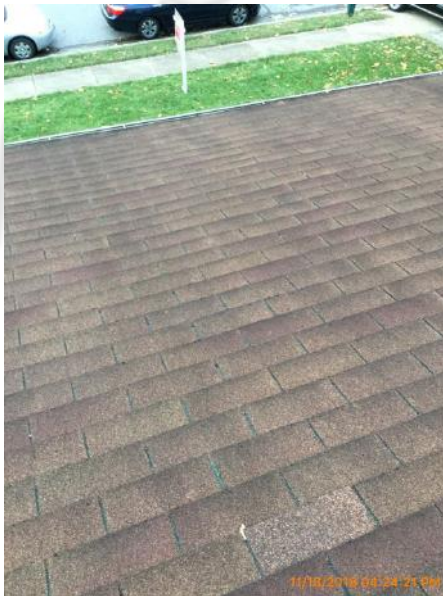
AGED 20: - Location: Covers whole building
